**Flood Control Project Maintenance
Levee Inspections**

Fall 2018 Levee Maintenance Deficiency Summary Report

San Joaquin River Basin

**Flood Control Project Maintenance
Levee Inspections****LMA District Cover Sheet****Fall 2018 Levee Inspection Results****Reclamation District No. 0524 Middle Roberts Island**

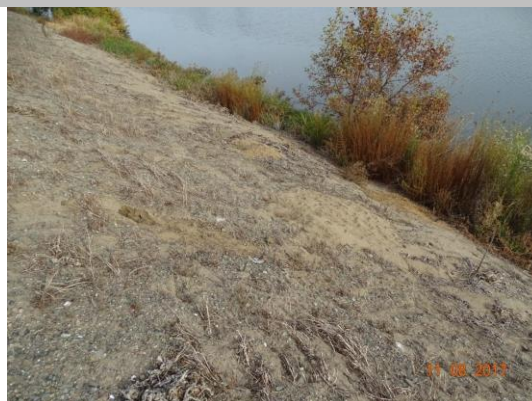
Photo 1 of 4 : FA_2018_RD0524_107_237_20180906_00329.jpg

LM Start	0.14	Rating **	A	Issue No.	237 (cont)
LM End	0.14	Issue Type +	Ma	Location *	WS

Looking northwest at the waterside slope.

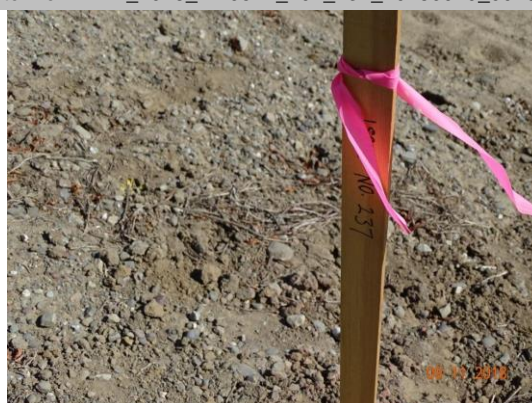
Photo 2 of 4 : FA_2018_RD0524_107_237_20180919_00466.jpg

Looking at site staking on waterward shoulder.(Fall 2018)

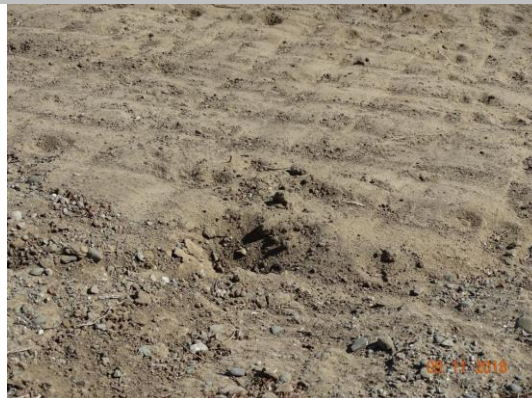
Photo 4 of 4 : FA_2018_RD0524_107_237_20180919_00467.jpg

LM Start	0.14	Rating **	A	Issue No.	237 (cont)	
LM End	0.14	Issue Type +	Ma	Location *	WS	
Category	Earthen Levee			GPS Latitude/Longitude		
				Start		End
Item	Animal Control			37.939774 °		37.939774 °
				-121.344490 °		-121.344490 °
DWR ID	DWR_RD0524_01_f_2017_237					
Comment Code						
A3 : No rodents visible, but rodent burrows visible; need to backfill and compact or grout burrows.						
Inspector Comment						
LMA backfilled rodent hole, but no rodent program visible.

Looking east at backfill on waterward slope. (Fall 2018)

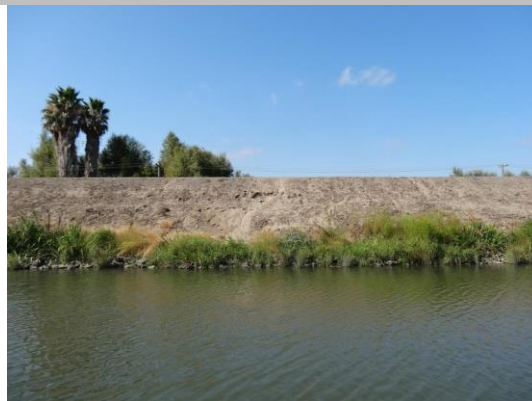
Photo 1 of 3 : FA_2018_RD0524_107_1_20180906_00001.jpg

LM Start	0.19	Rating **	U	Issue No.	1
LM End	0.19	Issue Type +	Ma	Location *	WS
Category	Supplemental			GPS Latitude/Longitude	
				Start	End
Item	DWR Erosion Survey			37.939085 °	37.939085 °
				-121.343917 °	-121.343917 °
DWR ID	RD0524U01RM40.85				
Comment Code					
Inspector Comment					
09/13/2017: No significant change observed.					
07/25/2016: No significant change observed.					
06/24/2015: No significant change observed.					
06/19/2014: No significant change observed.					
08/13/2013: The erosion was discovered during 2013 spring levee inspection. Inspector comment: Erosion is located along the lower level of water-ward slope. [2017 Site ID:RD0524U01RM40.85]

Close view of the erosion.

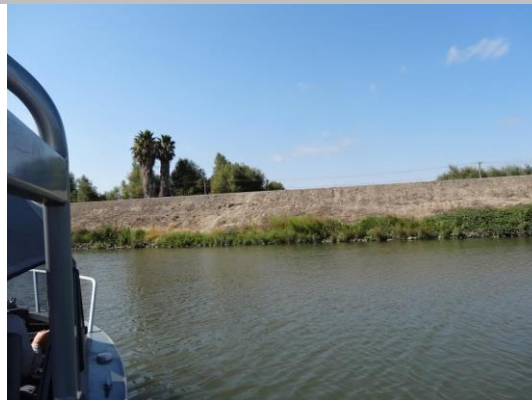
Photo 2 of 3 : FA_2018_RD0524_107_1_20180906_00002.jpg

LM Start	0.19	Rating **	U	Issue No.	1 (cont)	
LM End	0.19	Issue Type +	Ma	Location *	WS	
Category	Supplemental			GPS Latitude/Longitude		
				Start		End
Item	DWR Erosion Survey			37.939085 °		37.939085 °
				-121.343917 °		-121.343917 °
DWR ID	RD0524U01RM40.85					
Comment Code						
Inspector Comment						
09/13/2017: No significant change observed.						
07/25/2016: No significant change observed.						
06/24/2015: No significant change observed.						
06/19/2014: No significant change observed.						
08/13/2013: The erosion was discovered during 2013 spring levee inspection. Inspector comment: Erosion is located along the lower level of water-ward slope. [2017 Site ID:RD0524U01RM40.85]

Front view of the erosion.

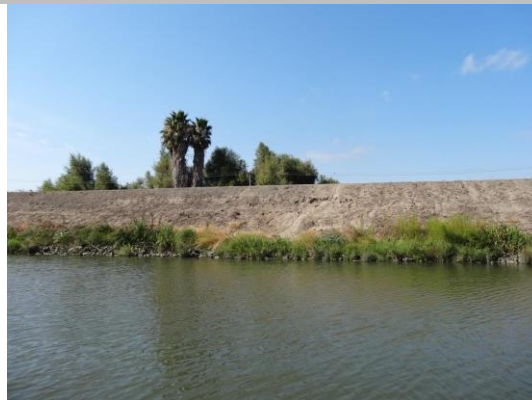
Photo 3 of 3 : FA_2018_RD0524_107_1_20180906_00003.jpg

Front view of the erosion.

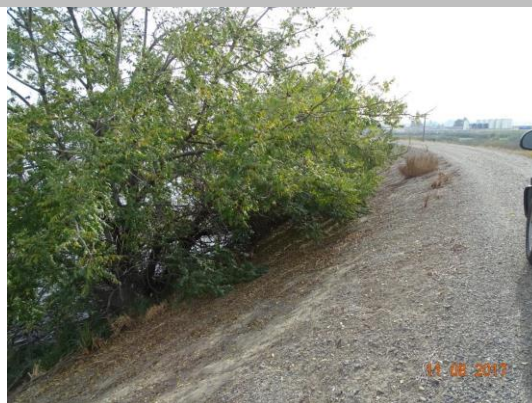
Photo 1 of 1 : FA_2018_RD0524_107_201_20180906_00266.jpg

LM Start	0.23	Rating **	U	Issue No.	201
LM End	0.23	Issue Type +	Ma	Location *	WS
Category	Earthen Levee			GPS Latitude/Longitude	
				Start	End
Item	Trim / Thin Trees			37.938648 °	37.938648 °
				-121.343480 °	-121.343480 °
DWR ID	DWR_RD0524_01_f_2016_201				
Comment Code					
T2 : Thin trees to allow visibility of the ground and room to flood fight.					
Inspector Comment					
Untrimmed trees on waterside slope.

Looking southeast at the waterside slope.

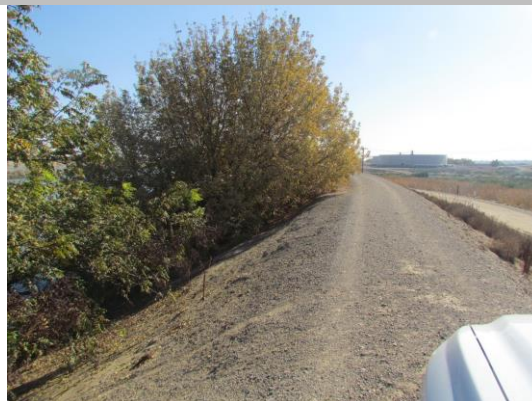
Photo 1 of 1 : FA_2018_RD0524_107_179_20180906_00235.jpg

LM Start	0.27	Rating **	U	Issue No.	179
LM End	0.27	Issue Type +	Ma	Location *	WS
Category	Earthen Levee			GPS Latitude/Longitude	
				Start	End
Item	Trim / Thin Trees			37.938438 °	37.938438 °
				-121.342883 °	-121.342883 °
DWR ID	DWR_RD0524_01_s_2014_179				
Comment Code					
T2 : Thin trees to allow visibility of the ground and room to flood fight.					
Inspector Comment					
Tree blocking view of waterside slope.

Looking east at untrimmed tree on waterward slope. (Fall 2016)

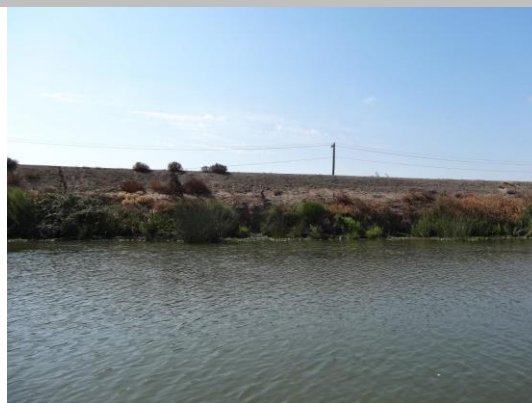
Photo 1 of 4 : FA_2018_RD0524_107_2_20180906_00004.jpg

LM Start	0.34	Rating **	M	Issue No.	2
LM End	0.34	Issue Type +	Ma	Location *	WS
Category	Supplemental			GPS Latitude/Longitude	
				Start	End
Item	DWR Erosion Survey			37.938461 °	37.938461 °
				-121.341526 °	-121.341526 °
DWR ID	RD0524U01RM40.93				
Comment Code					
Inspector Comment					
09/13/2017: There are two pocket erosions at the site; both erosions are around 10 ft long and 6 ft high. [2017 Site ID:RD0524U01RM40.93]

Front view of the erosion site.

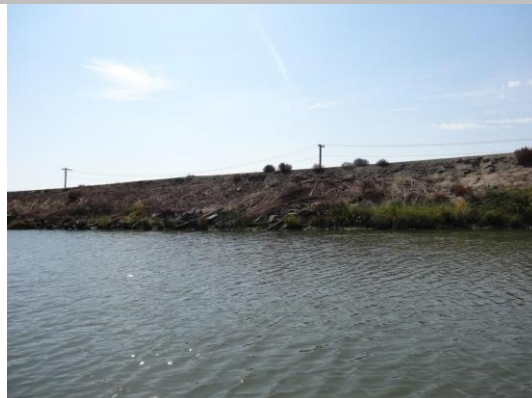
Photo 3 of 4 : FA_2018_RD0524_107_2_20180906_00006.jpg

LM Start	0.34	Rating **	M	Issue No.	2 (cont)	
LM End	0.34	Issue Type +	Ma	Location *	WS	
Category	Supplemental			GPS Latitude/Longitude		
				Start		End
Item	DWR Erosion Survey			37.938461 °		37.938461 °
				-121.341526 °		-121.341526 °
DWR ID	RD0524U01RM40.93					
Comment Code						
Inspector Comment						
09/13/2017: There are two pocket erosions at the site; both erosions are around 10 ft long and 6 ft high. [2017 Site ID:RD0524U01RM40.93]

Close view of the erosion site.

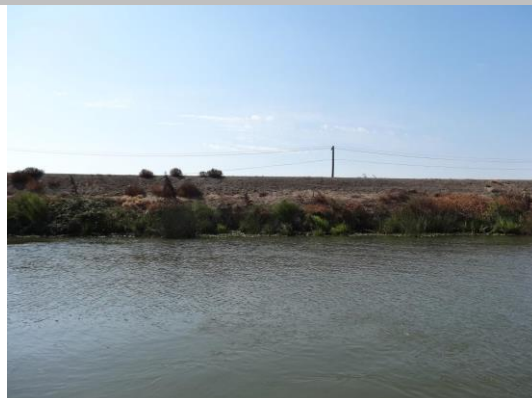
Photo 4 of 4 : FA_2018_RD0524_107_2_20180906_00007.jpg

Front view of the erosion.

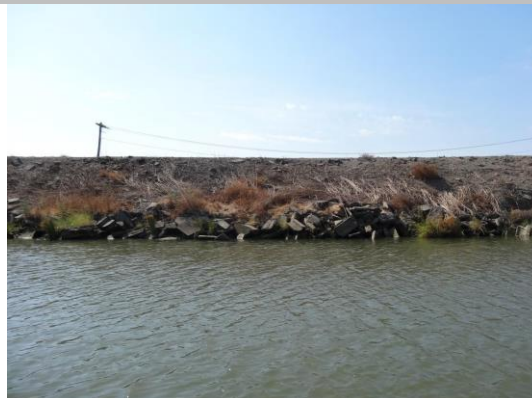
Photo 1 of 4 : FA_2018_RD0524_107_5_20180906_00011.jpg

LM Start	0.40	Rating **	M	Issue No.	5
LM End	0.40	Issue Type +	Ma	Location *	WS
Category	Supplemental			GPS Latitude/Longitude	
				Start	End
Item	DWR Erosion Survey			37.938870 °	37.938870 °
				-121.340460 °	-121.340460 °
DWR ID	RD0524U01RM40.99				
Comment Code					
Inspector Comment					
09/13/2017: No significant change observed.					
07/25/2016: More vegetation observed at the site.					
06/24/2015: No significant change observed.					
06/19/2014: No significant change observed.					
08/13/2013: No significant change at this site.					
08/07/2012: The erosion is at the upper levee slope, and likely caused by slope slip. The lower levee slope is covered with dense vegetation.					
[2017 Site ID:RD0524U01RM40.99]

Front view of the erosion site.

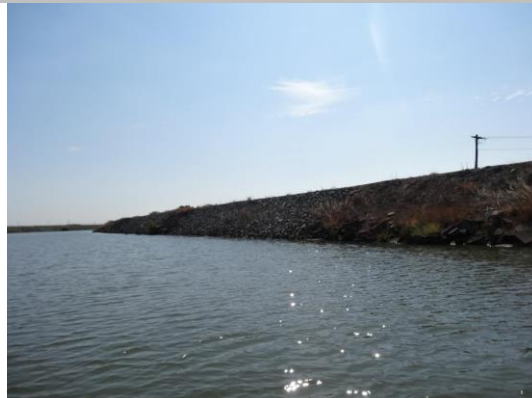
Photo 2 of 4 : FA_2018_RD0524_107_5_20180906_00012.jpg

Downstream view of the site.

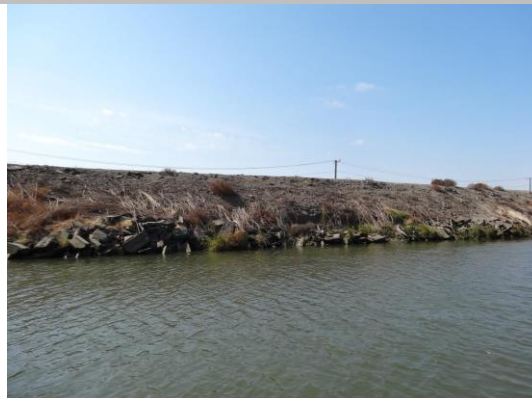
Photo 3 of 4 : FA_2018_RD0524_107_5_20180906_00013.jpg

LM Start	0.40	Rating **	M	Issue No.	5 (cont)	
LM End	0.40	Issue Type +	Ma	Location *	WS	
Category	Supplemental			GPS Latitude/Longitude		
				Start	End	
Item	DWR Erosion Survey			37.938870 °	37.938870 °	
				-121.340460 °	-121.340460 °	
DWR ID	RD0524U01RM40.99					
Comment Code						
Inspector Comment						
09/13/2017: No significant change observed.						
07/25/2016: More vegetation observed at the site.						
06/24/2015: No significant change observed.						
06/19/2014: No significant change observed.						
08/13/2013: No significant change at this site.						
08/07/2012: The erosion is at the upper levee slope, and likely caused by slope slip. The lower levee slope is covered with dense vegetation.						
[2017 Site ID:RD0524U01RM40.99]

Close view of the erosion.

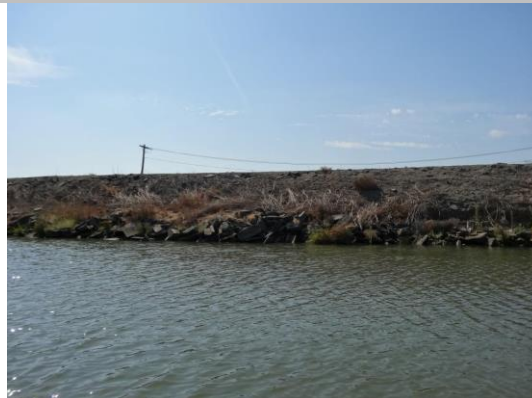
Photo 4 of 4 : FA_2018_RD0524_107_5_20180906_00014.jpg

Close view of the erosion.

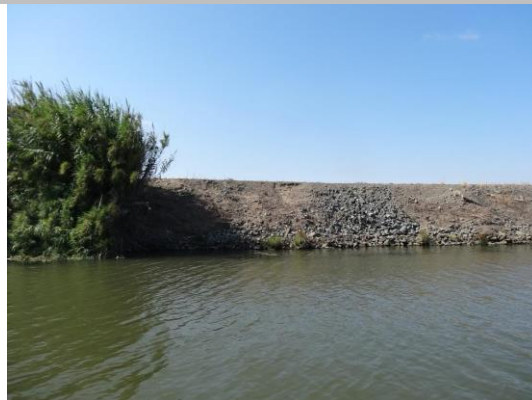
Photo 2 of 2 : FA_2018_RD0524_107_15_20180906_00025.jpg

LM Start	0.63	Rating **	M	Issue No.	15 (cont)	
LM End	0.63	Issue Type +	Ma	Location *	WS	
Category	Supplemental			GPS Latitude/Longitude		
				Start		End
Item	DWR Erosion Survey			37.938247 °		37.938247 °
				-121.336503 °		-121.336503 °
DWR ID	RD0524U01RM41.26					
Comment Code						
Inspector Comment						
09/13/2017: The erosion was discovered by levee inspection. The erosion site is immediately downstream of tall vegetations. [2017 Site ID:RD0524U01RM41.26]

Front view of the erosion.

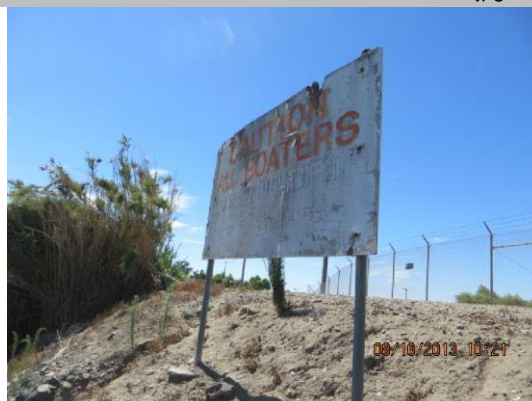
Photo 1 of 3 : UCIP_FA_2018_17563_29702.jpg

LM Start	0.67	Rating **	M	Issue No.	933
LM End	0.67	Issue Type +	En	Location *	
Category	Supplemental			GPS Latitude/Longitude	
				Start	End
Item	DWR UCIP Field Study			37.937891 °	37.937891 °
				-121.335939 °	-121.335939 °
DWR ID	20592				
Comment Code					
Inspector Comment					
FS_ID:17563 DS_ID:20592 EP_NO: 6035 Repair Type: Non-Urgent Crossing Status: Found UCIP Comments: Flows from primer tank causing erosion on LS slope. FIELD_STRUCT_DESC: 48-inch coated steel sewer pipe through the levee, 7.3 feet below the crown. Siphon pumps and primer tank enclosed by cyclone fence on the landside (LS) shoulder. Gate valve at inlet sump 100 feet off the LS toe. One concrete cutoff wall. (Permit No. 6035, 1968 - City of Stockton). [Additional Reference(s): DWR Levee Log, 2004]. FS Date: 8/16/2013

Signage for effluent pipe on WS shoulder.

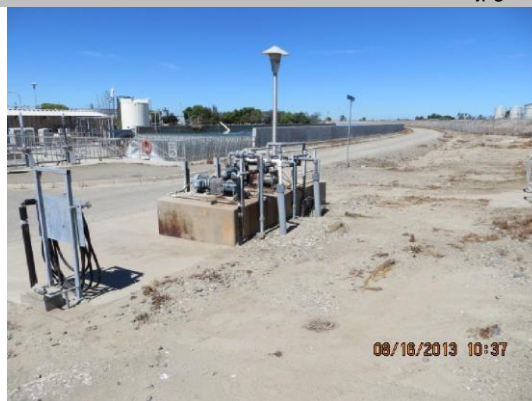
Photo 3 of 3 : UCIP_FA_2018_17563_29700.jpg

LM Start	0.67	Rating **	M	Issue No.	933 (cont)	
LM End	0.67	Issue Type +	En	Location *		
Category	Supplemental			GPS Latitude/Longitude		
				Start		End
Item	DWR UCIP Field Study			37.937891 °		37.937891 °
				-121.335939 °		-121.335939 °
DWR ID	20592					
Comment Code						
Inspector Comment						
FS_ID:17563 DS_ID:20592 EP_NO: 6035 Repair Type: Non-Urgent Crossing Status: Found UCIP Comments: Flows from primer tank causing erosion on LS slope. FIELD_STRUCT_DESC: 48-inch coated steel sewer pipe through the levee, 7.3 feet below the crown. Siphon pumps and primer tank enclosed by cyclone fence on the landside (LS) shoulder. Gate valve at inlet sump 100 feet off the LS toe. One concrete cutoff wall. (Permit No. 6035, 1968 - City of Stockton). [Additional Reference(s): DWR Levee Log, 2004]. FS Date: 8/16/2013

Vacuum pumps off LS toe.

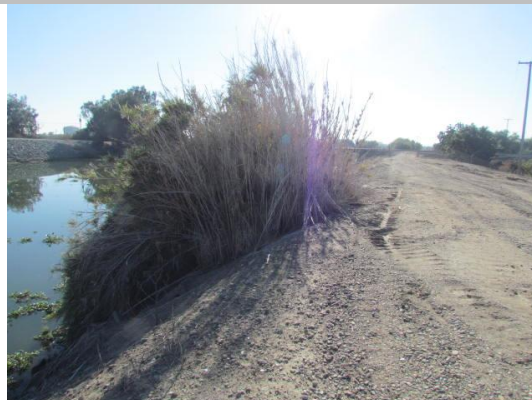
Photo 1 of 1 : FA_2018_RD0524_107_14_20180906_00023.jpg

LM Start	0.67	Rating **	U	Issue No.	14
LM End	0.67	Issue Type +	Ma	Location *	WS
Category	Earthen Levee			GPS Latitude/Longitude	
				Start	End
Item	Vegetation			37.937808 °	37.937808 °
				-121.335913 °	-121.335913 °
DWR ID	DWR_RD0524_01_s_2012_14				
Comment Code					
V2 : Remove the wild growth other than native grasses from the levee slopes.					
Inspector Comment					
Bamboo on waterside slope.Bamboo is dead but blocking view.

Looking south at dying bamboo on waterward slope. Fall 2015

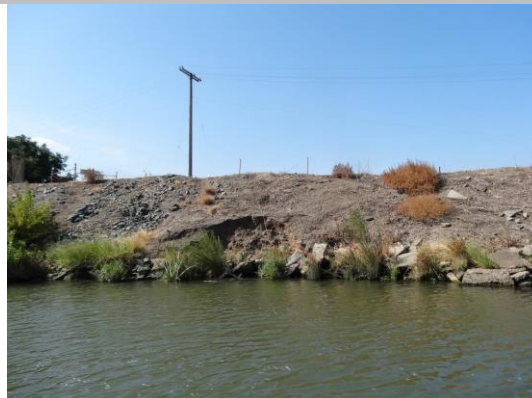
Photo 1 of 4 : FA_2018_RD0524_107_16_20180906_00026.jpg

Front view of the erosion.

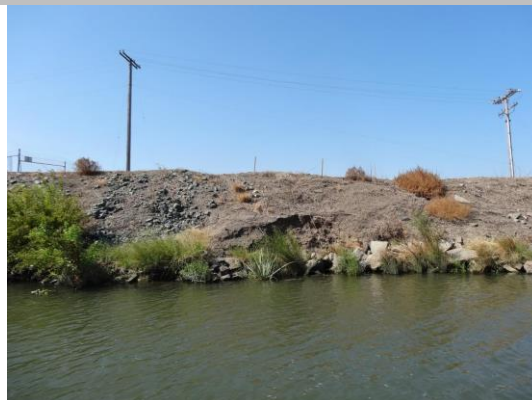
Photo 2 of 4 : FA_2018_RD0524_107_16_20180906_00027.jpg

Close view of the erosion.

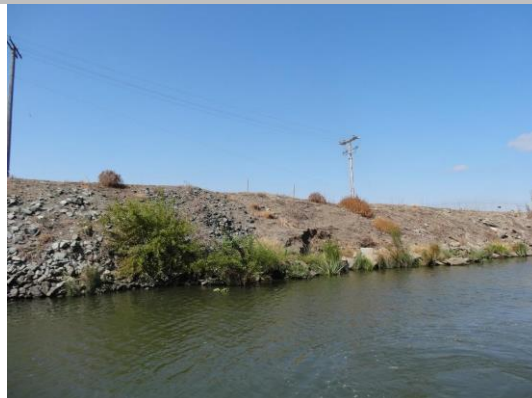
Photo 3 of 4 : FA_2018_RD0524_107_16_20180906_00028.jpg

Looking downstream of the erosion site.

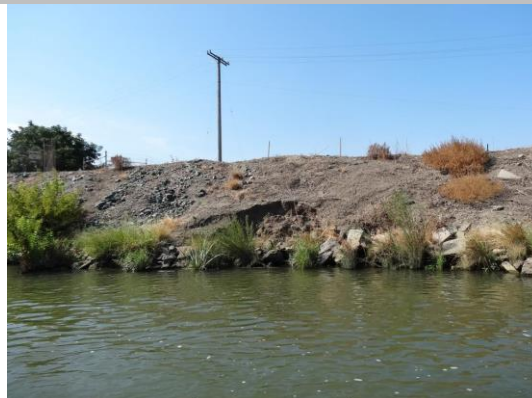
Photo 4 of 4 : FA_2018_RD0524_107_16_20180906_00029.jpg

LM Start	0.70	Rating **	M	Issue No.	16 (cont)	
LM End	0.70	Issue Type +	Ma	Location *	WS	
Category	Supplemental			GPS Latitude/Longitude		
				Start		End
Item	DWR Erosion Survey			37.937577 °		37.937577 °
				-121.335491 °		-121.335491 °
DWR ID	RD0524U01RM41.34					
Comment Code						
Inspector Comment						
09/13/2017: Pocket erosion above the protected levee toe. [2017 Site ID:RD0524U01RM41.34]

Close view of the erosion.

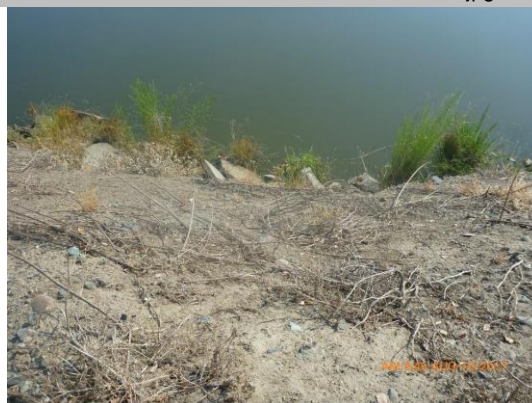
Photo 1 of 3 : LEVAL_FA_2018_541_4079.jpg

LM Start	0.70	Rating **	A/W	Issue No.	153
LM End	0.70	Issue Type +	Ma	Location *	
Category	Supplemental			GPS Latitude/Longitude	
				Start	End
Item	2017 Storm Damage			37.937500 °	37.937500 °
				-121.335500 °	-121.335500 °
DWR ID	DWR_RD0524_01_f_2017_153				
Comment Code					
Inspector Comment					
Levee Evaluation Comments					
Description:Slope protection repairs are needed along the waterside slope due to erosion and riprap displacement from high water. Based upon levee inspections, it was determined the waterside levee slope is eroding, deteriorating, and degrading. The eroded levee sections need to be restored back to design standards to prevent further deterioration and damage.					
Site ID No:541					
Site Designation:LMA-447					
Repair Type: Erosion					
Rating:Area of Concern					
Field Date:8/10/2017					
Notes:

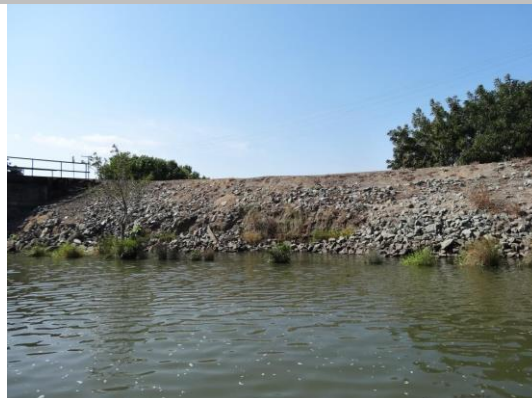
Photo 1 of 3 : FA_2018_RD0524_107_17_20180906_00030.jpg

LM Start	0.71	Rating **	M	Issue No.	17
LM End	0.73	Issue Type +	Ma	Location *	WS
Category	Supplemental			GPS Latitude/Longitude	
				Start	End
Item	DWR Erosion Survey			37.937222 °	37.937222 °
				-121.335277 °	-121.335277 °
DWR ID	RD0524U01RM41.36				
Comment Code					
Inspector Comment					
09/13/2017: No significant change observed.					
07/25/2016: No significant change observed.					
06/24/2015: The erosion site is immediately downstream of the RR bridge. [2017 Site ID:RD0524U01RM41.36]

Front view of the erosion.

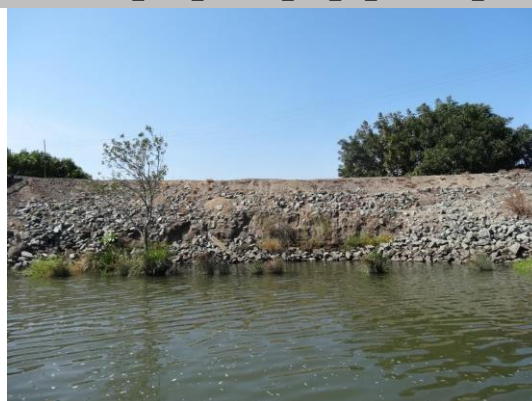
Photo 2 of 3 : FA_2018_RD0524_107_17_20180906_00031.jpg

Close view of the erosion.

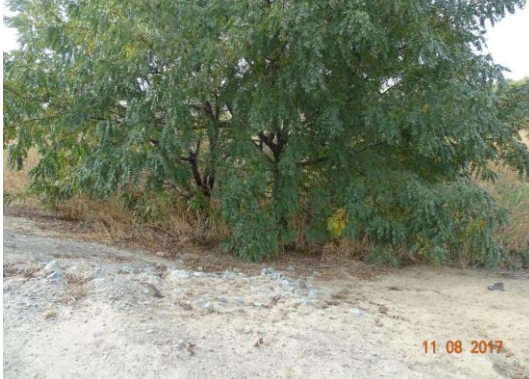
Photo 1 of 2 : FA_2018_RD0524_107_156_20180906_00208.jpg

Looking southwest at the landside slope.

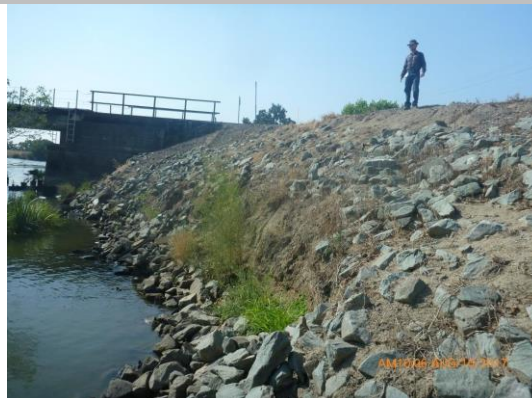
Photo 2 of 3 : LEVAL_FA_2018_540_4088.jpg

LM Start	0.72	Rating **	A/W	Issue No.	154 (cont)							
LM End	0.73	Issue Type +	Ma	Location *								
Category	Supplemental		GPS Latitude/Longitude									
			Start	End								
Item	2017 Storm Damage		37.937200°	37.937100°								
			-121.335300°	-121.335300°								
DWR ID	DWR_RD0524_01_f_2017_154											
Comment Code												
Inspector Comment												
Levee Evaluation Comments Description: Slope protection repairs are needed along the waterside slope due to erosion and riprap displacement from high water. Based upon levee inspections, it was determined the waterside levee slope is eroding, deteriorating, and degrading. The eroded levee sections need to be restored back to design standards to prevent further deterioration and damage. Site ID No: 540 Site Designation: LMA-446 Repair Type: Erosion Rating: Area of Concern Field Date: 8/10/2017 Notes:

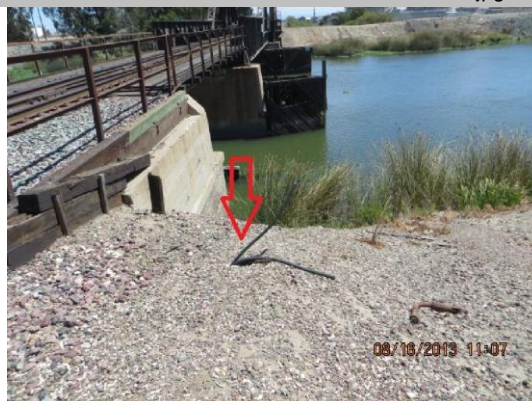
Photo 1 of 1 : UCIP_FA_2018_41463_29717.jpg

LM Start	0.74	Rating **	M	Issue No.	934	
LM End	0.74	Issue Type +	En	Location *		
Category	Supplemental			GPS Latitude/Longitude		
				Start	End	
Item	DWR UCIP Field Study			37.936951 °	37.936951 °	
				-121.335132 °	-121.335132 °	
DWR ID	20595					
Comment Code						
Inspector Comment						
FS_ID:41463 DS_ID:20595 EP_NO: N/A Repair Type: Non-Urgent Crossing Status: Indicator Found UCIP Comments: Appears abandoned and should be done so properly. FIELD_STRUCT_DESC: 2.5-inch telephone conduit of an unknown material through the levee, 2 feet below the crown and under the channel. Conduit visible on the waterside (WS) shoulder. [Additional Reference(s): DWR Levee Log, 2004]. FS Date: 8/16/2013

Conduit visible on WS shoulder next to bridge abutment. Cable appears to be abandoned.

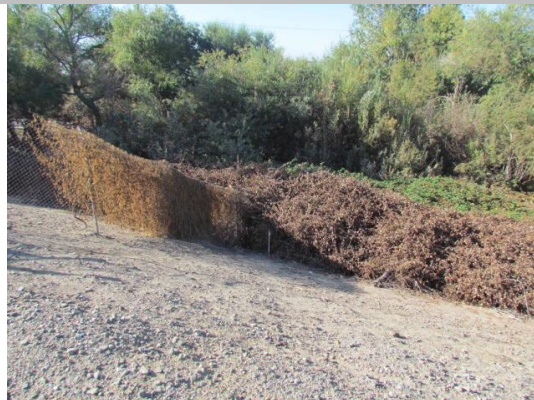
Photo 2 of 3 : FA_2018_RD0524_107_262_20180906_00348.jpg

LM Start	0.75	Rating **	U	Issue No.	262 (cont)	
LM End	0.78	Issue Type +	Ma	Location *	LS	
Category	Earthen Levee			GPS Latitude/Longitude		
				Start		End
Item	Vegetation			37.936813 °		37.936539 °
				-121.335019 °		-121.334863 °
DWR ID	DWR_RD0524_01_s_2012_262					
Comment Code						
V2 : Remove the wild growth other than native grasses from the levee slopes.						
Inspector Comment						
Dense vegetation at landside toe along fence line.

Looking west at dense vegetation at landward slope and toe fall 2015.

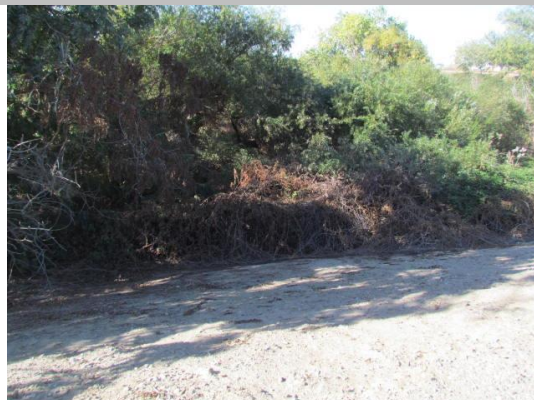
Photo 3 of 3 : FA_2018_RD0524_107_262_20180906_00349.jpg

Looking west at dense vegetation on landside toe. Spring 2014

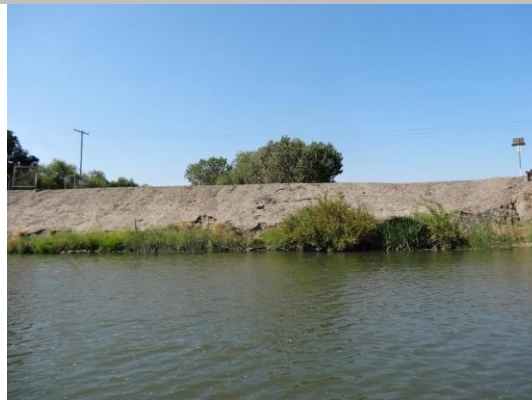
Photo 1 of 4 : FA_2018_RD0524_107_21_20180906_00036.jpg

LM Start	0.76	Rating **	U	Issue No.	21
LM End	0.77	Issue Type +	Ma	Location *	WS
Category	Supplemental			GPS Latitude/Longitude	
				Start	End
Item	DWR Erosion Survey			37.936821 °	37.936821 °
				-121.334582 °	-121.334582 °
DWR ID	RD0524U01RM41.39				
Comment Code					
Inspector Comment					
09/13/2017: No significant change observed.					
07/25/2016: No significant change observed.					
06/24/2015: No significant change observed.					
06/19/2014: No significant change observed.					
08/13/2013: No significant change at this site.					
08/07/2012: The site has been visited by boat survey. No significant change observed.					
08/23/2011: The site is located immediately upstream of a Railroad bridge. Dense vegetation at the water line blocks the view of erosion.					
[2017 Site ID:RD0524U01RM41.39]

Front view of the erosion site.

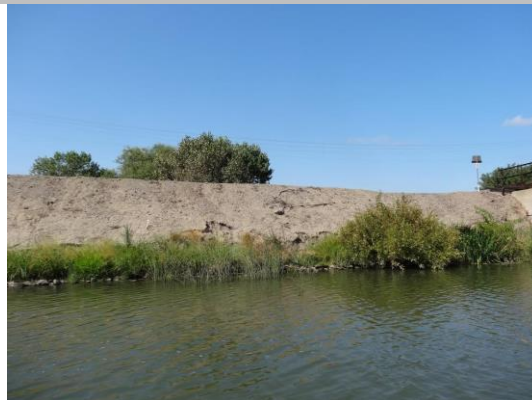
Photo 3 of 4 : FA_2018_RD0524_107_21_20180906_00038.jpg

LM Start	0.76	Rating **	U	Issue No.	21 (cont)
LM End	0.77	Issue Type +	Ma	Location *	WS
Category	Supplemental			GPS Latitude/Longitude	
				Start	End
Item	DWR Erosion Survey			37.936821 °	37.936821 °
				-121.334582 °	-121.334582 °
DWR ID	RD0524U01RM41.39				
Comment Code					
Inspector Comment					
09/13/2017: No significant change observed.					
07/25/2016: No significant change observed.					
06/24/2015: No significant change observed.					
06/19/2014: No significant change observed.					
08/13/2013: No significant change at this site.					
08/07/2012: The site has been visited by boat survey. No significant change observed.					
08/23/2011: The site is located immediately upstream of a Railroad bridge. Dense vegetation at the water line blocks the view of erosion.					
[2017 Site ID:RD0524U01RM41.39]

Front view of the erosion.

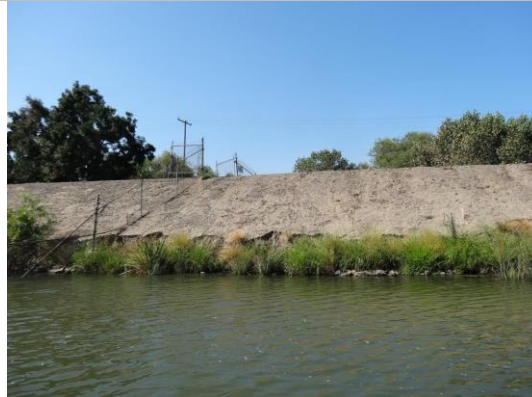
Photo 4 of 4 : FA_2018_RD0524_107_21_20180906_00039.jpg

Front view of the erosion.

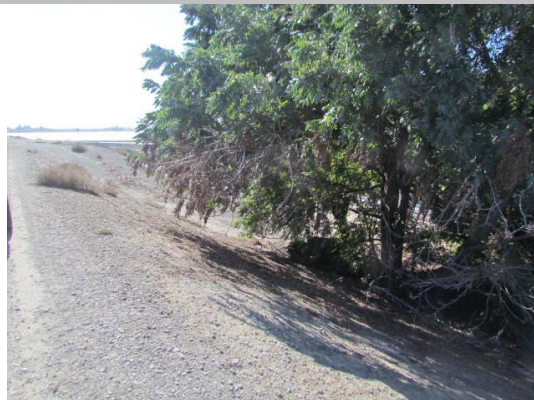
Photo 1 of 1 : FA_2018_RD0524_107_76_20180906_00133.jpg

LM Start	0.78	Rating **	U	Issue No.	76
LM End	0.78	Issue Type +	Ma	Location *	LS
Category	Earthen Levee			GPS Latitude/Longitude	
				Start	End
Item	Trim / Thin Trees			37.936444 °	37.936444 °
				-121.334797 °	-121.334797 °
DWR ID	DWR_RD0524_01_s_2012_76				
Comment Code					
T1 : Trim trees to at least five feet above ground level.					
Inspector Comment

Looking southwest at low hanging tree branches at landside toe.

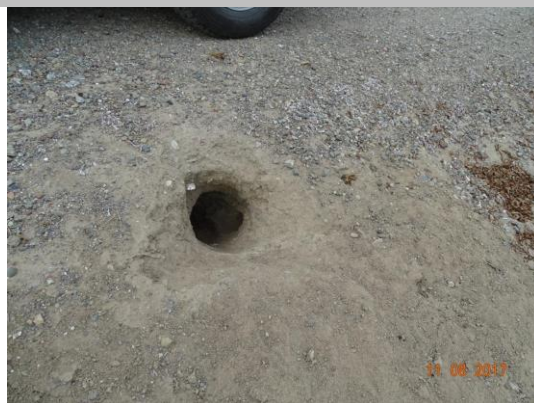
Photo 1 of 1 : FA_2018_RD0524_107_239_20180906_00334.jpg

LM Start	0.79	Rating **	U	Issue No.	239
LM End	0.79	Issue Type +	Ma	Location *	WS
Category	Earthen Levee			GPS Latitude/Longitude	
				Start	End
Item	Animal Control			37.936413 °	37.936413 °
				-121.334779 °	-121.334779 °
DWR ID	DWR_RD0524_01_f_2017_239				
Comment Code					
A3 : No rodents visible, but rodent burrows visible; need to backfill and compact or grout burrows.					
Inspector Comment

Looking west at the waterside shoulder.

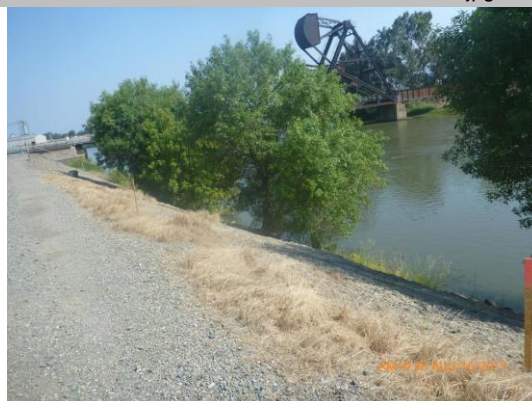
Photo 1 of 3 : LEVAL_FA_2018_538_4097.jpg

LM Start	0.79	Rating **	M	Issue No.	155
LM End	0.80	Issue Type +	Ma	Location *	
Category	Supplemental			GPS Latitude/Longitude	
				Start	End
Item	2017 Storm Damage			37.936300 °	37.936200 °
				-121.334700 °	-121.334600 °
DWR ID	DWR_RD0524_01_f_2017_155				
Comment Code					
Inspector Comment					
Levee Evaluation Comments					
Description:Slope protection repairs are needed along the waterside slope due to erosion and riprap displacement from high water. Based upon levee inspections, it was determined the waterside levee slope is eroding, deteriorating, and degrading. The eroded levee sections need to be restored back to design standards to prevent further deterioration and damage.					
Site ID No:538					
Site Designation:LMA-444					
Repair Type: Erosion					
Rating:Area of Concern					
Field Date:8/10/2017					
Notes:

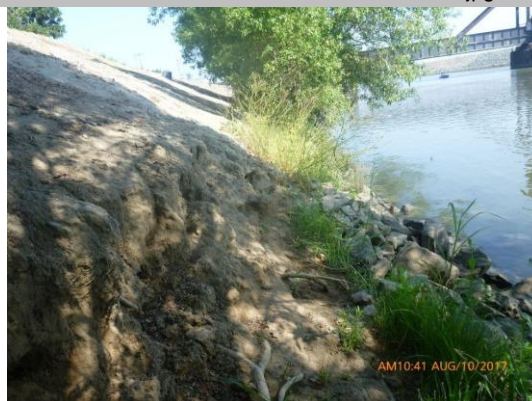
Photo 3 of 3 : LEVAL_FA_2018_538_4099.jpg

LM Start	0.79	Rating **	M	Issue No.	155 (cont)
LM End	0.80	Issue Type +	Ma	Location *	
Category	Supplemental			GPS Latitude/Longitude	
				Start	End
Item	2017 Storm Damage			37.936300 °	37.936200 °
				-121.334700 °	-121.334600 °
DWR ID	DWR_RD0524_01_f _ 2017_155				
Comment Code					
Inspector Comment					
Levee Evaluation Comments					
Description:Slope protection repairs are needed along the waterside slope due to erosion and riprap displacement from high water. Based upon levee inspections, it was determined the waterside levee slope is eroding, deteriorating, and degrading. The eroded levee sections need to be restored back to design standards to prevent further deterioration and damage.					
Site ID No:538					
Site Designation:LMA-444					
Repair Type: Erosion					
Rating:Area of Concern					
Field Date:8/10/2017					
Notes:

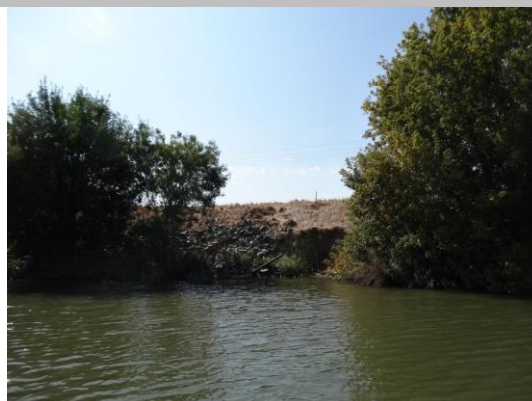
Photo 1 of 3 : FA_2018_RD0524_107_29_20180906_00050.jpg

LM Start	0.91	Rating **	U	Issue No.	29
LM End	0.91	Issue Type +	Ma	Location *	WS
Category	Supplemental			GPS Latitude/Longitude	
				Start	End
Item	DWR Erosion Survey			37.935576 °	37.935576 °
				-121.333202 °	-121.333202 °
DWR ID	RD0524U01RM41.5				
Comment Code					
Inspector Comment					
09/13/2017: No significant change observed.					
07/25/2016: No significant change observed.					
06/24/2015: No significant change observed.					
06/19/2014: No significant change observed.					
08/13/2013: No significant change at this site.					
08/07/2012: The site has been visited by boat survey. No significant change observed					
08/23/2011: The erosion site is immediately downstream of the riprap protection. [2017 Site ID:RD0524U01RM41.5]

Front view of the erosion. Note the riprap protection near the site.

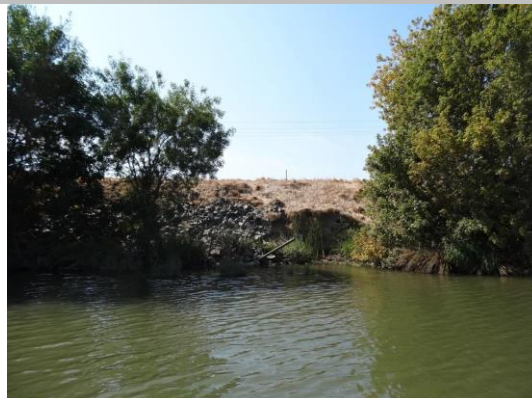
Photo 3 of 3 : FA_2018_RD0524_107_29_20180906_00052.jpg

LM Start	0.91	Rating **	U	Issue No.	29 (cont)	
LM End	0.91	Issue Type +	Ma	Location *	WS	
Category	Supplemental			GPS Latitude/Longitude		
				Start		End
Item	DWR Erosion Survey			37.935576 °		37.935576 °
				-121.333202 °		-121.333202 °
DWR ID	RD0524U01RM41.5					
Comment Code						
Inspector Comment						
09/13/2017: No significant change observed.						
07/25/2016: No significant change observed.						
06/24/2015: No significant change observed.						
06/19/2014: No significant change observed.						
08/13/2013: No significant change at this site.						
08/07/2012: The site has been visited by boat survey. No significant change observed						
08/23/2011: The erosion site is immediately downstream of the riprap protection. [2017 Site ID:RD0524U01RM41.5]

Close view of the erosion.

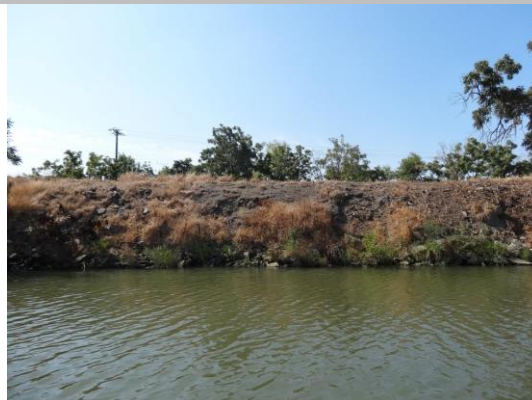
Photo 1 of 4 : FA_2018_RD0524_107_30_20180906_00053.jpg

LM Start	1.00	Rating **	U	Issue No.	30
LM End	1.00	Issue Type +	Ma	Location *	WS
Category	Supplemental			GPS Latitude/Longitude	
				Start	End
Item	DWR Erosion Survey			37.935410°	37.935410°
				-121.331560°	-121.331560°
DWR ID	RD0524U01RM41.58				
Comment Code					
Inspector Comment					
09/13/2017: No significant change observed.					
07/25/2016: No significant change observed.					
06/24/2015: No significant change observed.					
06/19/2014: No significant change observed.					
08/13/2013: No significant change at this site.					
08/07/2012: The erosion was discovered during the boat survey. [2017					
Site ID:RD0524U01RM41.58]

Front view of the erosion.

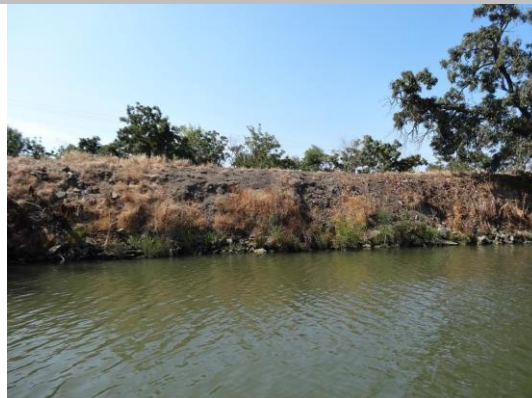
Photo 2 of 4 : FA_2018_RD0524_107_30_20180906_00054.jpg

LM Start	1.00	Rating **	U	Issue No.	30 (cont)
LM End	1.00	Issue Type +	Ma	Location *	WS
Category	Supplemental			GPS Latitude/Longitude	
				Start	End
Item	DWR Erosion Survey			37.935410 °	37.935410 °
				-121.331560 °	-121.331560 °
DWR ID	RD0524U01RM41.58				
Comment Code					
Inspector Comment					
09/13/2017: No significant change observed.					
07/25/2016: No significant change observed.					
06/24/2015: No significant change observed.					
06/19/2014: No significant change observed.					
08/13/2013: No significant change at this site.					
08/07/2012: The erosion was discovered during the boat survey. [2017					
Site ID:RD0524U01RM41.58]

Close view of the erosion.

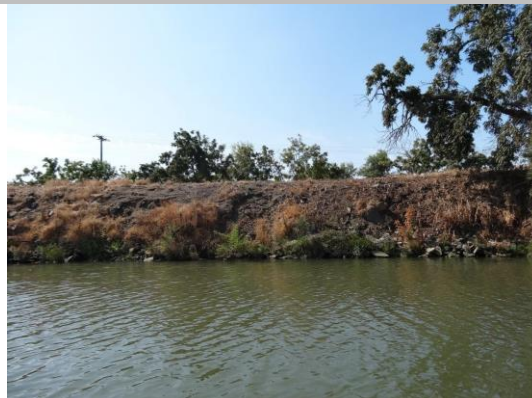
Photo 3 of 4 : FA_2018_RD0524_107_30_20180906_00055.jpg

Front view of the erosion.

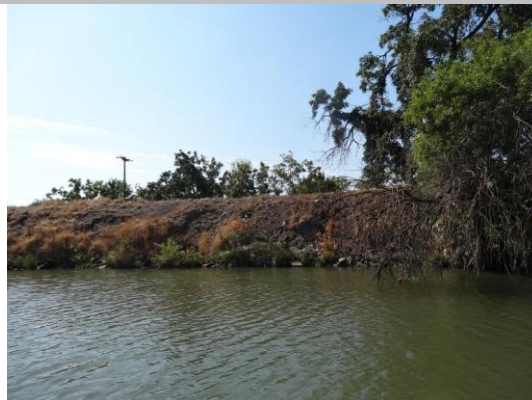
Photo 4 of 4 : FA_2018_RD0524_107_30_20180906_00056.jpg

Downstream view of the erosion.

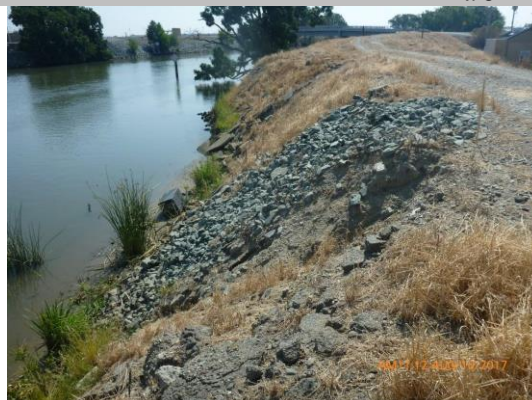
Photo 1 of 3 : LEVAL_FA_2018_536_4109.jpg

LM Start	1.00	Rating **	A/W	Issue No.	198
LM End	1.01	Issue Type +	Ma	Location *	
Category	Supplemental			GPS Latitude/Longitude	
				Start	End
Item	2017 Storm Damage			37.935100 °	37.935100 °
				-121.331500 °	-121.331300 °
DWR ID	DWR_RD0524_01_f _ 2017_198

Comment Code					
Inspector Comment					
Levee Evaluation Comments					
Description:Slope protection repairs are needed along the waterside slope due to erosion and riprap displacement from high water. Based upon levee inspections, it was determined the waterside levee slope is eroding, deteriorating, and degrading. The eroded levee sections need to be restored back to design standards to prevent further deterioration and damage.					
Site ID No:536					
Site Designation:LMA-442					
Repair Type: Erosion					
Rating:Area of Concern					
Field Date:8/10/2017					
Notes: Appears to be previous repair site adjacent to LMA-442. Large fox den on land side

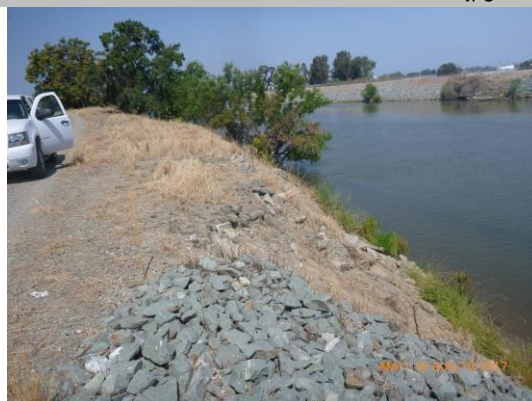
Photo 3 of 3 : LEVAL_FA_2018_536_4111.jpg

Comment Code					
Inspector Comment					
Levee Evaluation Comments					
Description:Slope protection repairs are needed along the waterside slope due to erosion and riprap displacement from high water. Based upon levee inspections, it was determined the waterside levee slope is eroding, deteriorating, and degrading. The eroded levee sections need to be restored back to design standards to prevent further deterioration and damage.					
Site ID No:536					
Site Designation:LMA-442					
Repair Type: Erosion					
Rating:Area of Concern					
Field Date:8/10/2017					
Notes: Appears to be previous repair site adjacent to LMA-442. Large fox den on land side

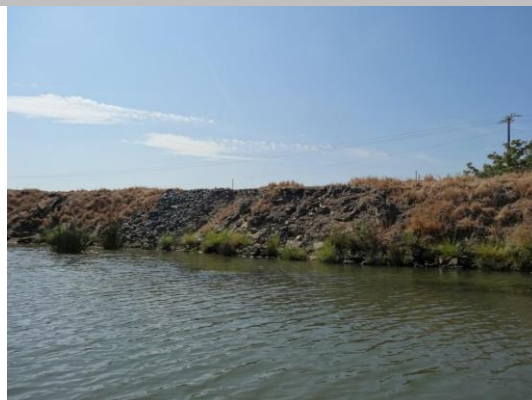
Photo 1 of 3 : FA_2018_RD0524_107_33_20180906_00061.jpg

LM Start	1.02	Rating **	U	Issue No.	33
LM End	1.02	Issue Type +	Ma	Location *	WS
Category	Supplemental			GPS Latitude/Longitude	
				Start	End
Item	DWR Erosion Survey			37.935078 °	37.935078 °
				-121.331134 °	-121.331134 °
DWR ID	RD0524U01RM41.59				
Comment Code					
Inspector Comment					
09/13/2017: No significant change observed.					
07/25/2016: No significant change observed.					
06/24/2015: No significant change observed.					
06/19/2014: No significant change observed.					
08/13/2013: No significant change at this site.					
08/07/2012: The site has been visited by boat survey. Site has been repaired, but new erosion occurred at the levee slope and immediately upstream of the repaired site.					
08/23/2011: The site is about 500 ft downstream of bridge. The levee toe seems to be protected, but the protection is being washed away.					
[2017 Site ID:RD0524U01RM41.59]

Upstream view of the site.

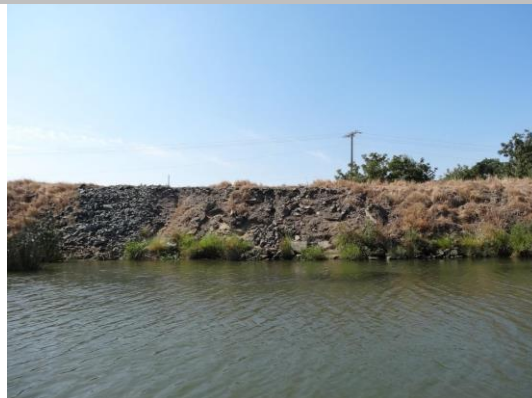
Photo 2 of 3 : FA_2018_RD0524_107_33_20180906_00062.jpg

Comment Code						
Inspector Comment						
09/13/2017: No significant change observed.						
07/25/2016: No significant change observed.						
06/24/2015: No significant change observed.						
06/19/2014: No significant change observed.						
08/13/2013: No significant change at this site.						
08/07/2012: The site has been visited by boat survey. Site has been repaired, but new erosion occurred at the levee slope and immediately upstream of the repaired site.						
08/23/2011: The site is about 500 ft downstream of bridge. The levee toe seems to be protected, but the protection is being washed away.						
[2017 Site ID:RD0524U01RM41.59]

Close view of the erosion.

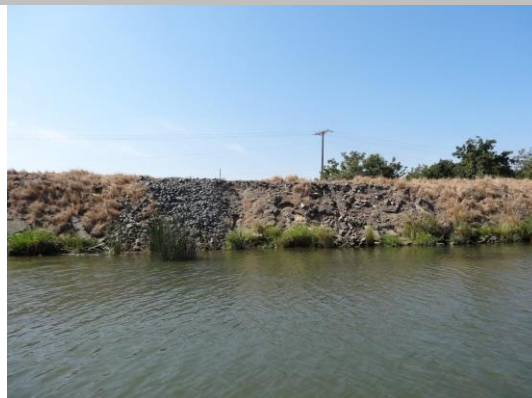
Photo 3 of 3 : FA_2018_RD0524_107_33_20180906_00063.jpg

Front view of the site.

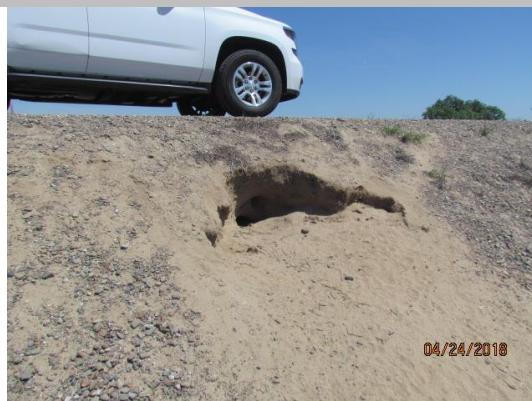
Photo 1 of 2 : FA_2018_RD0524_107_238_20180906_00330.jpg

Looking east at large rodent hole on landward slope. (Spring 2018)

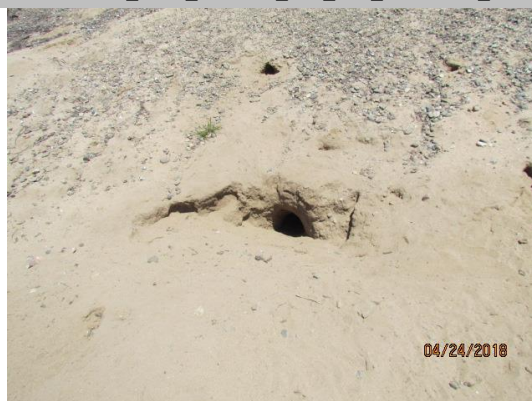
Photo 2 of 2 : FA_2018_RD0524_107_238_20180906_00332.jpg

Looking northeast at rodent hole on landward slope. (Spring 2018)

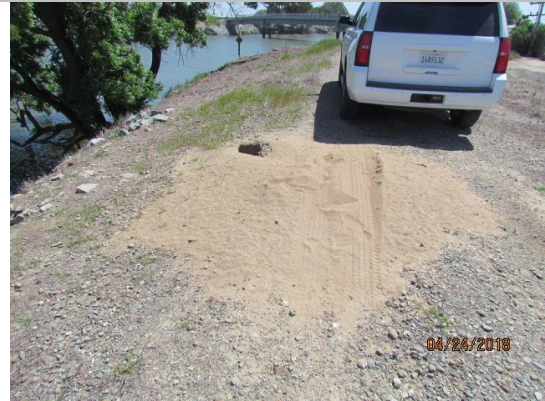
Photo 2 of 3 : FA_2018_RD0524_107_150_20180906_00192.jpg

LM Start	1.04	Rating **	U	Issue No.	150 (cont)	
LM End	1.04	Issue Type +	Ma	Location *	WS	
Category	Earthen Levee			GPS Latitude/Longitude		
				Start		End
Item	Animal Control			37.934896 °		37.934896 °
				-121.330781 °		-121.330781 °
DWR ID	DWR_RD0524_01_s_2018_150					
Comment Code						
A3 : No rodents visible, but rodent burrows visible; need to backfill and compact or grout burrows.						
Inspector Comment						
Large rodent or beaver or nutria hole on waterward shoulder and crown of levee. Over 2 cubic feet of material was observed beside hole.

Looking south at large rodent hole on waterward shoulder. (Spring 2018)

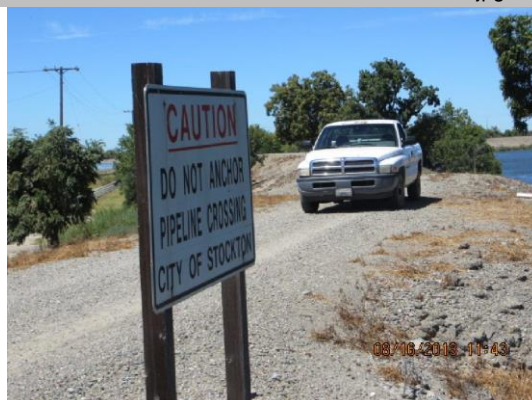
Photo 2 of 3 : UCIP_FA_2018_17589_29747.jpg

Caution sign on WS shoulder.

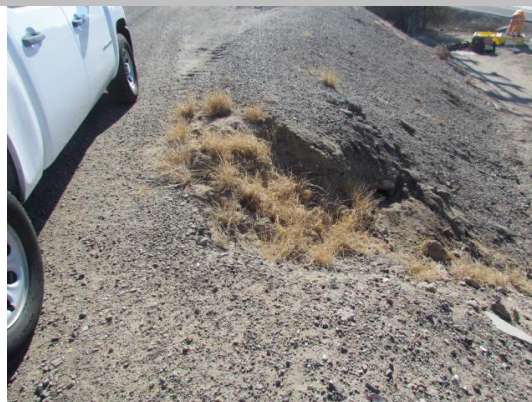
Photo 1 of 2 : FA_2018_RD0524_107_18_20180906_00033.jpg

LM Start	1.07	Rating **	U	Issue No.	18
LM End	1.07	Issue Type +	Ma	Location *	LS
Category	Earthen Levee			GPS Latitude/Longitude	
				Start	End
Item	Slope Stability			37.934715 °	37.934715 °
				-121.330343 °	-121.330343 °
DWR ID	DWR_RD0524_01_s_2012_18				
Comment Code					
S1 : Repair slope instability.					
Inspector Comment					
Slope damage extends from shoulder to middle of slope.

Looking south at caving on landward shoulder. (Fall 2015)

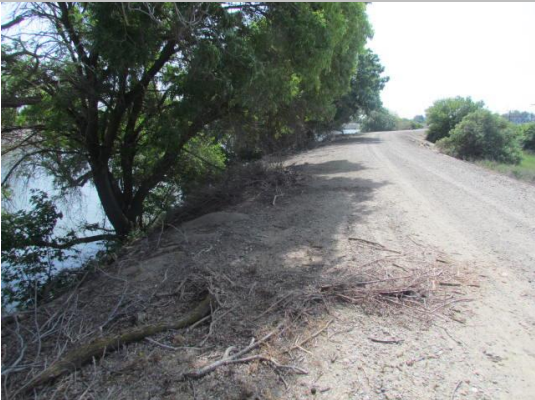
Photo 1 of 1 : FA_2018_RD0524_107_171_20180906_00223.jpg

Looking south at prunings on waterward shoulders.

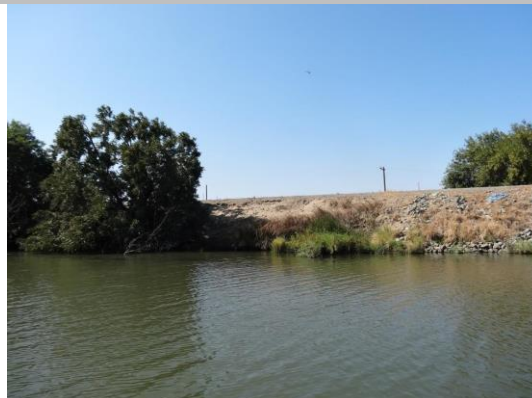
Photo 1 of 4 : FA_2018_RD0524_107_44_20180906_00073.jpg

Comment Code					
Inspector Comment					
09/13/2017: No significant change observed.					
07/25/2016: No significant change observed.					
06/24/2015: No significant change observed.					
06/19/2014: No significant change observed.					
08/13/2013: No significant change at this site.					
08/07/2012: The site has been visited by boat survey. No significant change observed					
08/23/2011: No significant change observed on site.					
09/07/2010: No significant change observed on site. Vegetation is visible at the water line. There is an exposed pipe discharge partially hanging at the mid-slope, possibly still used for discharging irrigation/runoff water. There is minimal rip rap protection along the bank, and what's left of it is no longer adequately protecting the bank.					
9/29/2009: Site consists of a 400-foot long eroding bank with minimal vegetation and protection; the existing rip rap has sloughed, rendering it useless; note that there is an exposed section of a pipe.

Direct view of the site.

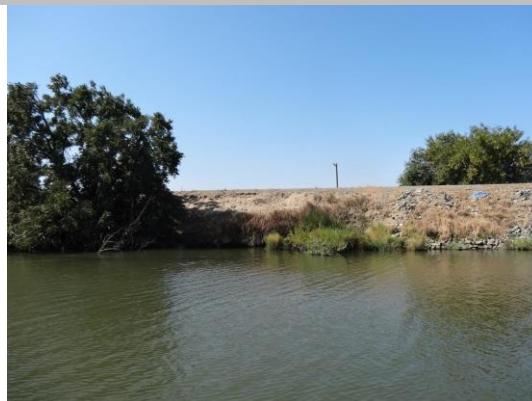
Photo 2 of 4 : FA_2018_RD0524_107_44_20180906_00074.jpg

Direct view of the site.

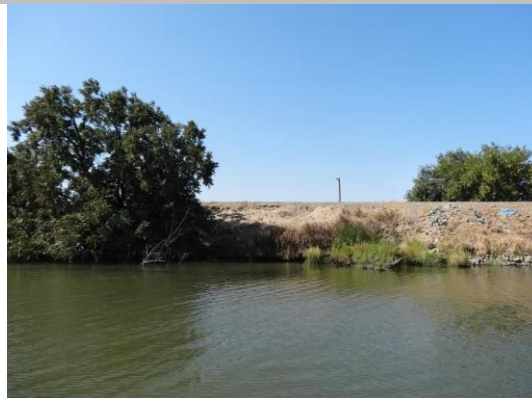
Photo 3 of 4 : FA_2018_RD0524_107_44_20180906_00075.jpg

Comment Code						
Inspector Comment						
09/13/2017: No significant change observed.						
07/25/2016: No significant change observed.						
06/24/2015: No significant change observed.						
06/19/2014: No significant change observed.						
08/13/2013: No significant change at this site.						
08/07/2012: The site has been visited by boat survey. No significant change observed						
08/23/2011: No significant change observed on site.						
09/07/2010: No significant change observed on site. Vegetation is visible at the water line. There is an exposed pipe discharge partially hanging at the mid-slope, possibly still used for discharging irrigation/runoff water. There is minimal rip rap protection along the bank, and what's left of it is no longer adequately protecting the bank.						
9/29/2009: Site consists of a 400-foot long eroding bank with minimal vegetation and protection; the existing rip rap has sloughed, rendering it useless; note that there is an exposed section of a pipe.

View of the erosion.

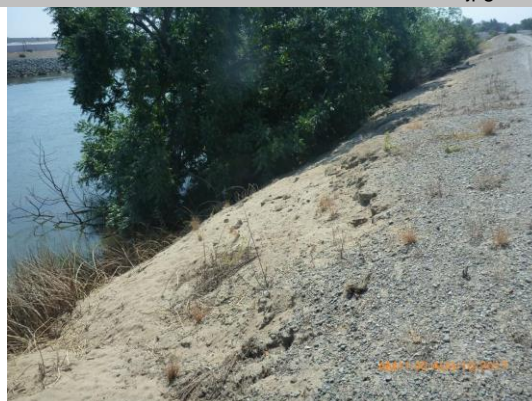
Photo 2 of 3 : LEVAL_FA_2018_535_4116.jpg

LM Start	1.18	Rating **	A/W	Issue No.	221 (cont)	
LM End	1.20	Issue Type +	Ma	Location *		
Category	Supplemental			GPS Latitude/Longitude		
				Start	End	
Item	2017 Storm Damage			37.933500 °	37.933200 °	
				-121.329100 °	-121.328900 °	
DWR ID	DWR_RD0524_01_f_2017_221					
Comment Code						
Inspector Comment						
Levee Evaluation Comments						
Description:Slope protection repairs are needed along the waterside slope due to erosion and riprap displacement from high water. Based upon levee inspections, it was determined the waterside levee slope is eroding, deteriorating, and degrading. The eroded levee sections need to be restored back to design standards to prevent further deterioration and damage.						
Site ID No:535						
Site Designation:LMA-441						
Repair Type: Erosion						
Rating:Area of Concern						
Field Date:8/10/2017						
Notes:

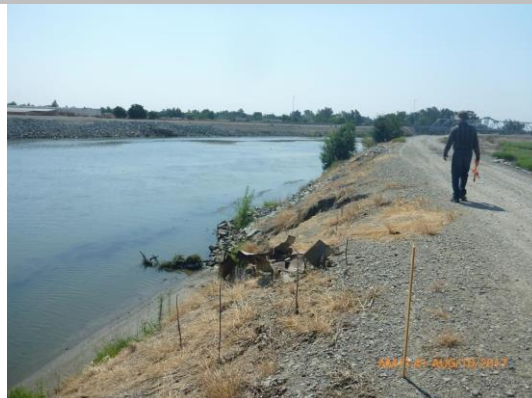
Photo 1 of 3 : LEVAL_FA_2018_534_4121.jpg

Description: Slope protection repairs are needed along the waterside slope due to erosion and riprap displacement from high water. Based upon levee inspections, it was determined the waterside levee slope is eroding, deteriorating, and degrading. The eroded levee sections need to be restored back to design standards to prevent further deterioration and damage.

Notes: site is related to, but not combined with, LMA-439 a portion of this site has been repaired.

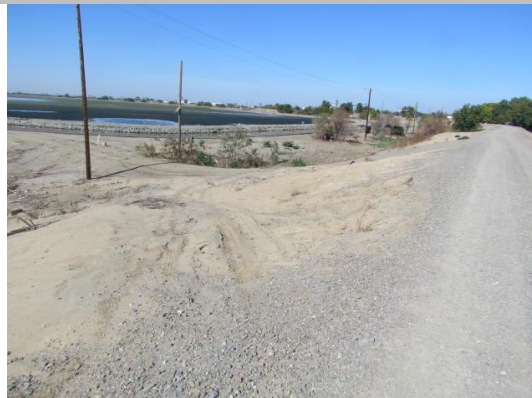
Photo 1 of 2 : FA_2018_RD0524_107_263_20180906_00350.jpg

LM Start	1.25	Rating **	U	Issue No.	263
LM End	1.25	Issue Type +	En	Location *	LS
Category	Earthen Levee			GPS Latitude/Longitude	
				Start	End
Item	Encroachments			37.932533 °	37.932533 °
				-121.328650 °	-121.328650 °
DWR ID	DWR_RD0524_01_s_2012_263				
Comment Code					
RA : Ramp					
Inspector Comment					
Unauthorized ramps on landside slope. Ramps were caused by vehicle traffic.

Looking northwest at unauthorized ramp on landside slope.

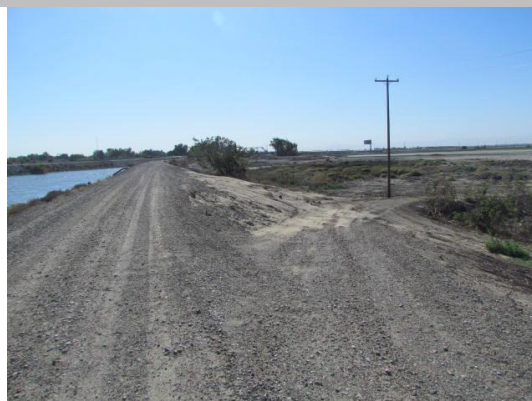
Photo 2 of 2 : FA_2018_RD0524_107_263_20180906_00351.jpg

LM Start	1.25	Rating **	U	Issue No.	263 (cont)	
LM End	1.25	Issue Type +	En	Location *	LS	
Category	Earthen Levee			GPS Latitude/Longitude		
				Start	End	
Item	Encroachments			37.932533 °	37.932533 °	
				-121.328650 °	-121.328650 °	
DWR ID	DWR_RD0524_01_s_2012_263					
Comment Code						
RA : Ramp						
Inspector Comment						
Unauthorized ramps on landside slope. Ramps were caused by vehicle traffic.

Looking south at unauthorized ramp on landside slope.
